== USS O'BANNON (DD-987) ==
SEMAT I SHELL CONDITION ASSESSMENT
SURVEY
INTERIOR AREAS
11/10/01 TO 11/21/01

PREPARED BY
SUPERVISOR OF SHIPBUILDING CONVERSION
AND
REPAIR
PORTSMOUTH, VIRGINIA
11/26/01

USS O'BANNON (DD-987)
SHELL CONDITION ASSESSMENT SURVEY, INTERIOR AREAS.

A SEMAT I UNDERWATER HULL AND SUPPORTING STRUCTURE SURVEY OF INTERIOR AREAS WAS CONDUCTED ON BOARD **USS O'BANNON (DD-987)** FROM 11/09/01 TO 11/21/01 AT ATLANTIC DRYDOCK CORPORATION JACKSONVILLE FLORIDA.

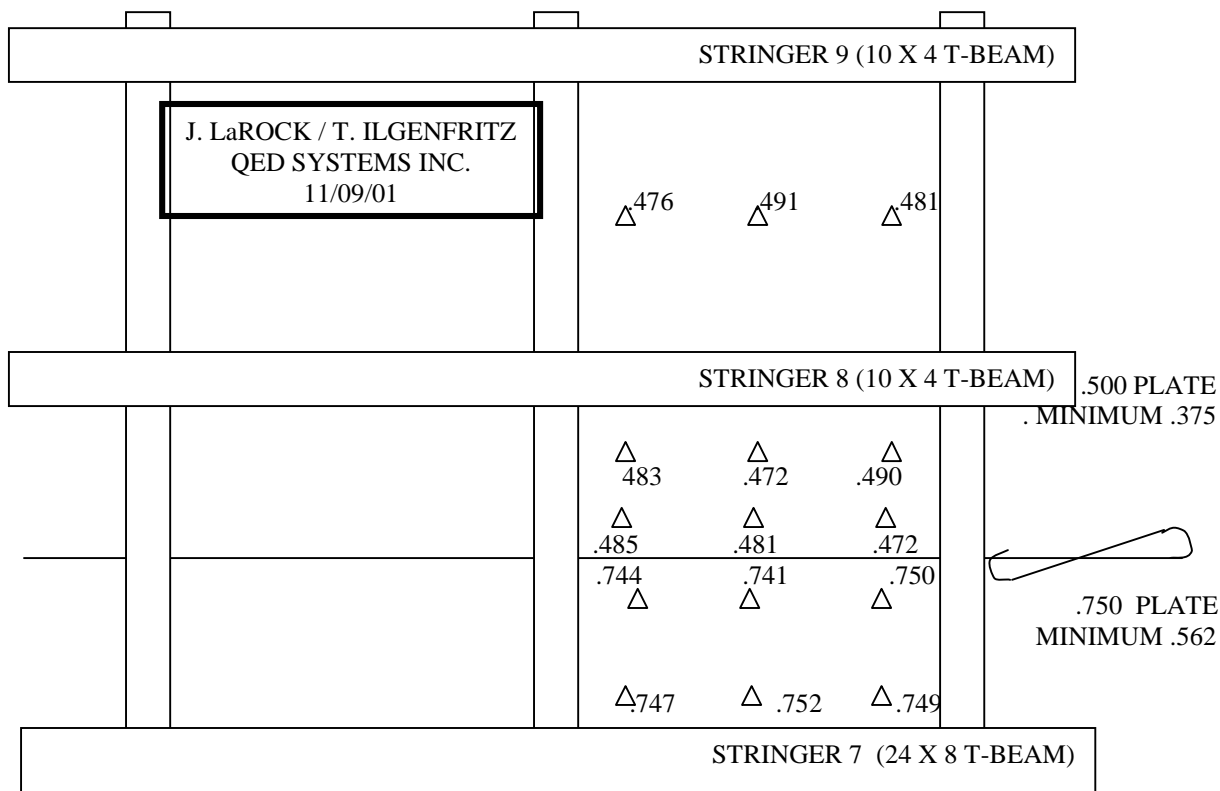
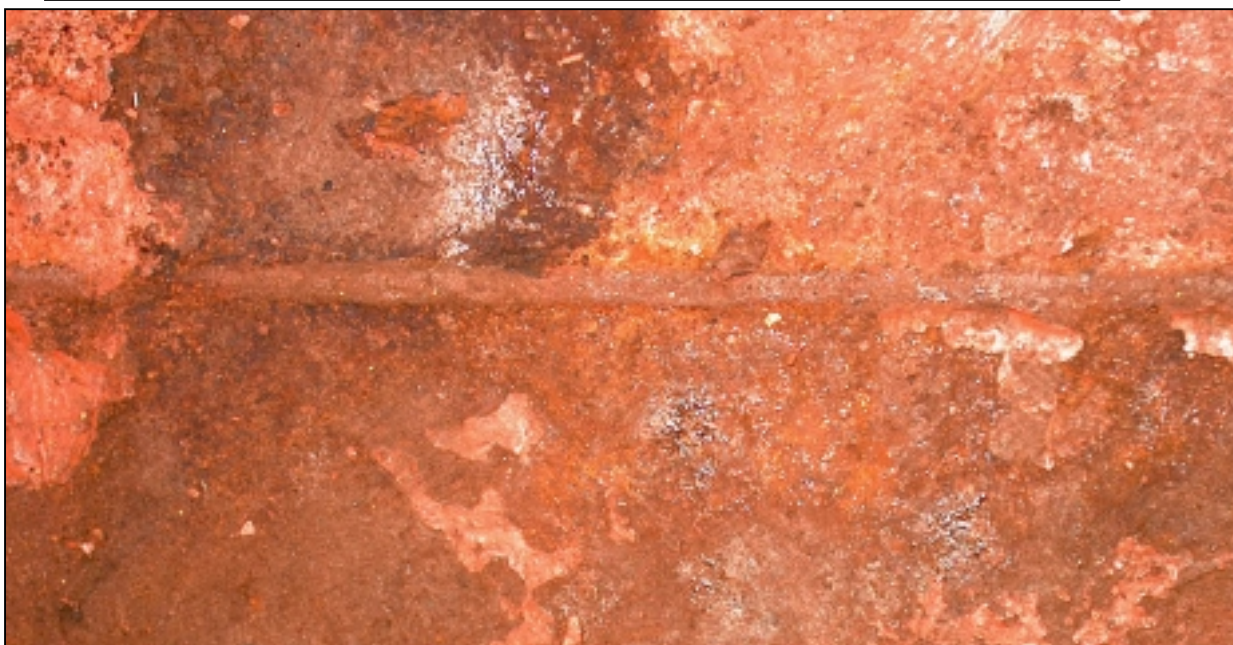
USS O'BANNON (DD-987)
STEERING GEAR ROOM ((6-506-0-E)
 STBD SIDE

DISCREPANCY DESCRIPTION: PER SEMAT I UNDERWATER HULL ASSESSMENT: STBD SIDE, (6-506-0-E) STEERING GEAR ROOM					
BETWEEN WEB FRAMES (512-515) AND STRINGERS (7-9), SHELL PLATE HAS RUST, HEAVY PAINT SEPARATION.					
U/T READINGS ARE WITHIN THE 25% WASTAGE CRITERIA.					
RECOMMENDED REPAIRS					
RECOMMEND SHIPS FORCE CLEAN AREA TO BARE METAL, PRIME AND PAINT APPROXIMATELY 20 SF					
SSPORT C221 POC: J. BRUCKNER (757) 396-4001 EXT 2186, TPOC: J. LaROCK (757) 490-5047					
CSMP SUMMARY:				TEST#	
BETWEEN WEB FRAMES (512-515) AND STRINGERS (7-9), SHELL PLATE HAS CORROSION				MRC 1102/1	
ROOT CAUSE/AMPLIFICATION:				STEP#	
H1				1,2,3,4 & 5	
SYSTEM LEVEL IMPACT:					
PART NO.	NOMENCLATURE		QTY	NSN	COST
1					
2					
3					
4					
5					
FIRST CONTACT MEIRS	RATE DC1	SECOND CONTACT BEHERNS	RATE DC3	PHONE	
ASSESSOR / ACT / TECH ID# J. LaROCK/ T. ILGENFRITZ QED SYSTEMS INC.			TD	TL	LOGISTICIAN
					TSP

CORROSION, PAINT SEPARATION ON SHELL PLATE BETWEEN WEB FRAMES (512-515)
 AND STRINGERS (7-8), U/T READINGS ARE SATISFACTORY.

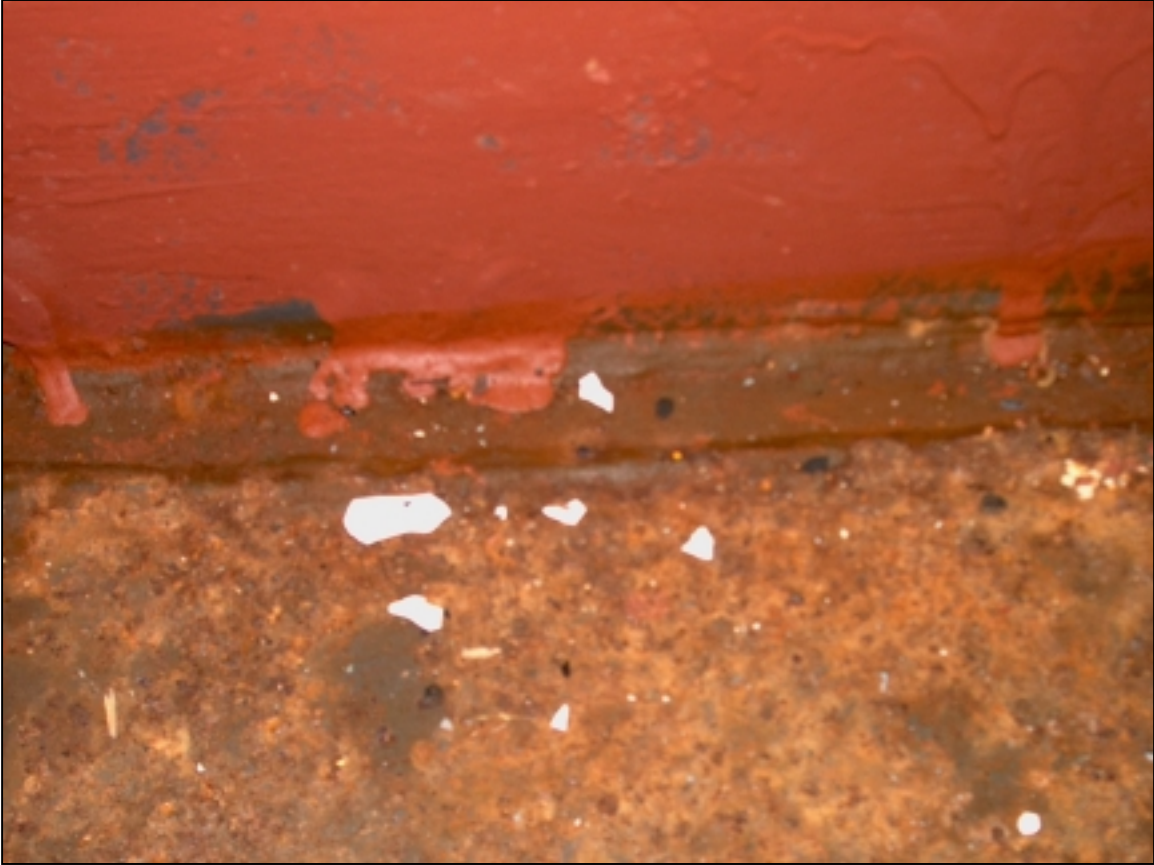
USS O'BANNON (DD-987)
REEL STOREROOM NO.1 (6-488-3-A)

DISCREPANCY DESCRIPTION: PER SEMAT I UNDERWATER HULL ASSESSMENT: (6-488-3-A) REEL STOREROOM NO. 1					
SHELL PLATE AFT OF BHD (488) HAS CORROSION APPROXIMATELY 20 SF. NUMBERS ON BULLSEYE ARE MARKED					
INNOCORRECT.					
RECOMMENDED REPAIRS					
RECOMMEND SHIP'S FORCE CLEAN AREA TO BARE METAL, PRESERVE AND PAINT APPROXIMATELY 20 SF					
SSPORT C221 POC: J. BRUCKNER (757) 396-4001 EXT 2186, TPOC: J. LaROCK (757) 490-5047					
CSMP SUMMARY: SHELL PLATE AFT OF BHD (488) HAS CORROSION.				TEST# MRC 1102/1	
ROOT CAUSE/AMPLIFICATION: H1				STEP# 1,2,3,4 & 5	
SYSTEM LEVEL IMPACT:					
PART NO.	NOMENCLATURE		QTY	NSN	COST
1					
2					
3					
4					
5					
6					
FIRST CONTACT MEIRS		RATE DC1	SECOND CONTACT BEHERNS		RATE DC3
ASSESSOR / ACT / TECH ID# J. LaROCK/ T. ILGENFRITZ QED SYSTEMS INC.			TD	TL	LOGISTICIAN
					TSP

CORROSION ON SHELL PLATE AFT OF BHD (488)

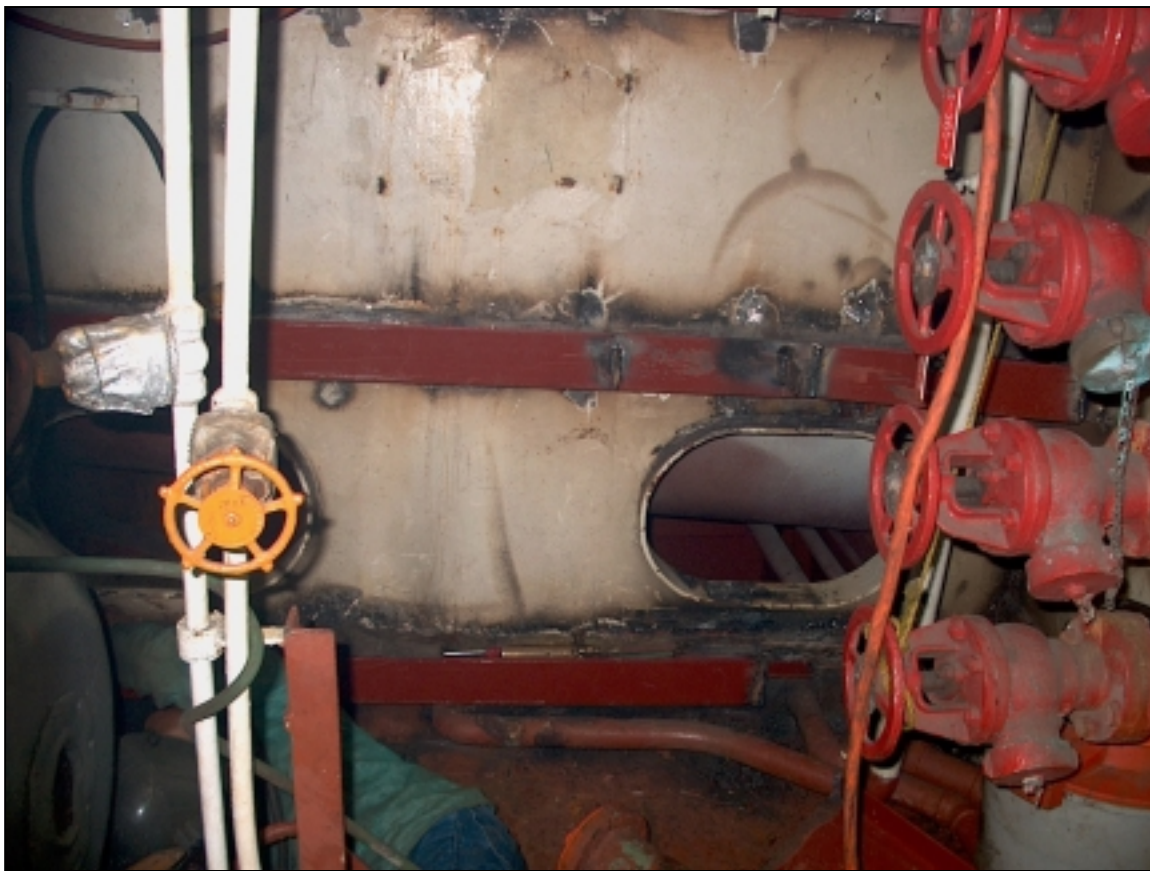
USS O'BANNON (DD-987)
SHAFT ALLEY (6-346-0-Q)

REPAIRS IN PROGRESS, STARBOARD SIDE SWASH BULKHEAD.

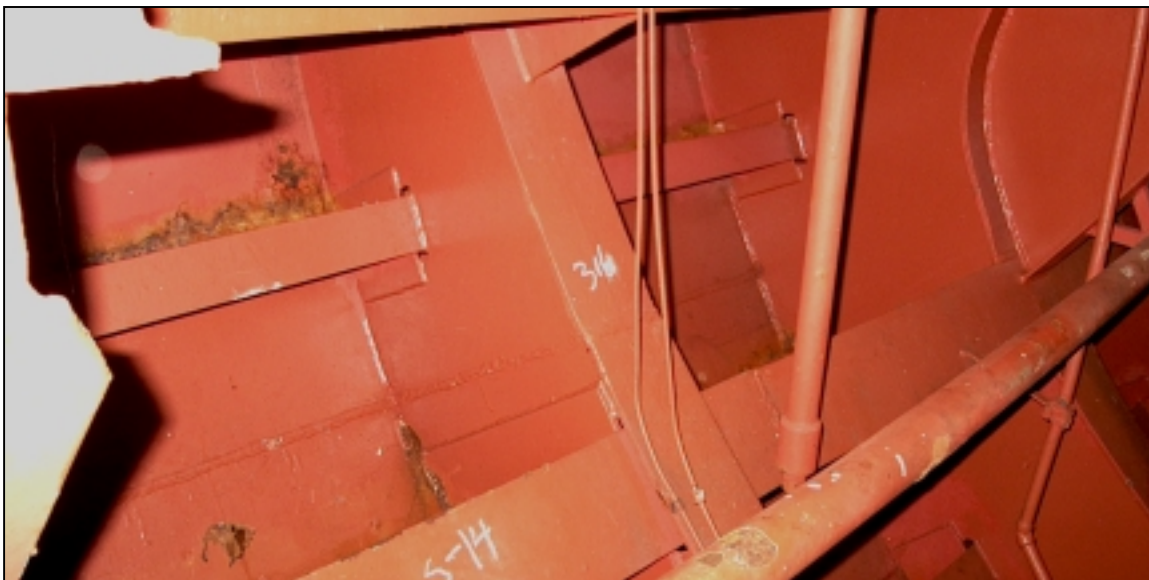
STARBOARD SIDE, STRINGERS (14-15) AT WEB FRAME (316)

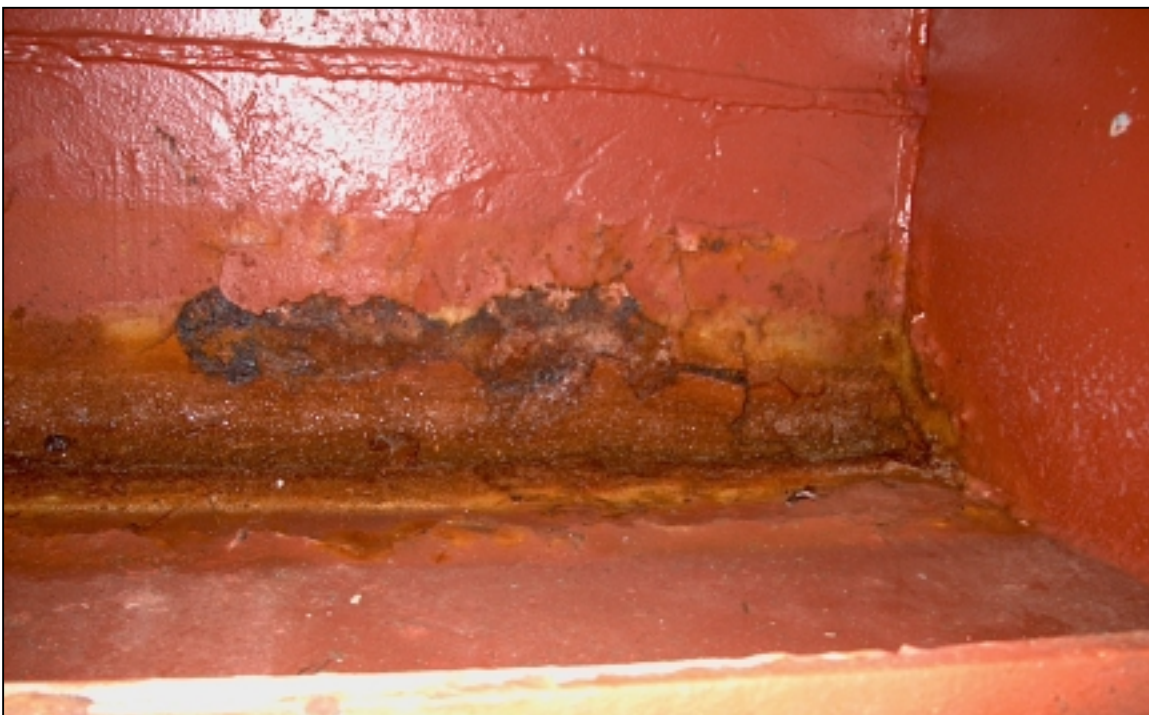
SAFETY HAZARD: 1. SERIOUS - CORRECT AS SOON AS POSSIBLE 2. SERIOUS - SUSPENSION OF EQUIPMENT/SYSTEM/SPACE REQUIRED 3. SERIOUS - WAIVER OF EQUIPMENT/SYSTEM 4. SAFETY ITEM - MINOR 5. COMBUSTIBLE MATERIAL		1. MAINTENANCE ACTION COMPLETED: PARTS DRAWN FROM SUPPLY 2. MAINTENANCE ACTION COMPLETED: REQUIRED PARTS NOT DRAWN FROM SUPPLY 3. MAINTENANCE ACTION COMPLETED: NO PARTS REQUIRED 4. CANCELLED - DEFERRAL WILL BE REMOVED FROM CSMP 5. MAINTENANCE ACTION COMPLETED: 3-M CAPABILITY UTILIZED 6. NONE OF THE ABOVE, DESCRIBE IN REMARKS/DESCRIPTION SECTION			1. MANDATORY 2. ESSENTIAL 3. HIGHLY DESIRABLE 4. DESIRABLE
DISCREPANCY DESCRIPTION: PER SEMAT I UNDERWATER HULL ASSESSMENT: STBD SIDE, (5-300-0-E) MAIN ENGINE ROOM 2					
STRINGER (14), AT SHELL PLATE BETWEEN WEB FRAMES (308 - 324). SHELL AND STRINGER HAVE RUST, HEAVY PAINT SEPARATION. APPROXIMATELY 60 SF OF AREA. U/T READINGS ARE SATISFACTORY, SEE DRAWING.

CORROSION ON SHELL AND STRINGER (14) FWD OF WEB FRAME (316), U/T READINGS WERE SATISFACTORY, SEE DRAWING.

RECOMMENDED REPAIR					
RECOMMEND SHIP'S FORCE CLEAN AREA TO BARE METAL, PRIME AND PAINT APPROXIMATELY 60 SF.					
SSPORT C221 POC: J. BRUCKNER (757) 396-4001 EXT 2186, TPOC: J. LaROCK (757) 490-5047					
CSMP SUMMARY:				TEST#	
STRINGERS AND SHELL HAVE RUST AND PAINT SEPARATION.				MRC 1102/1	
ROOT CAUSE/AMPLIFICATION:				STEP#	
H1				1,2,3,4 & 5	
SYSTEM LEVEL IMPACT:					
PART NO.	NOMENCLATURE	QTY	NSN	COST	
1					
2					
3					
4					
5					
6					
FIRST CONTACT MEIRS	RATE DC1	SECOND CONTACT BEHERNS	RATE DC3	PHONE	
ASSESSOR / ACT / TECH ID#		TD	TL	LOGISTICIAN	TSP

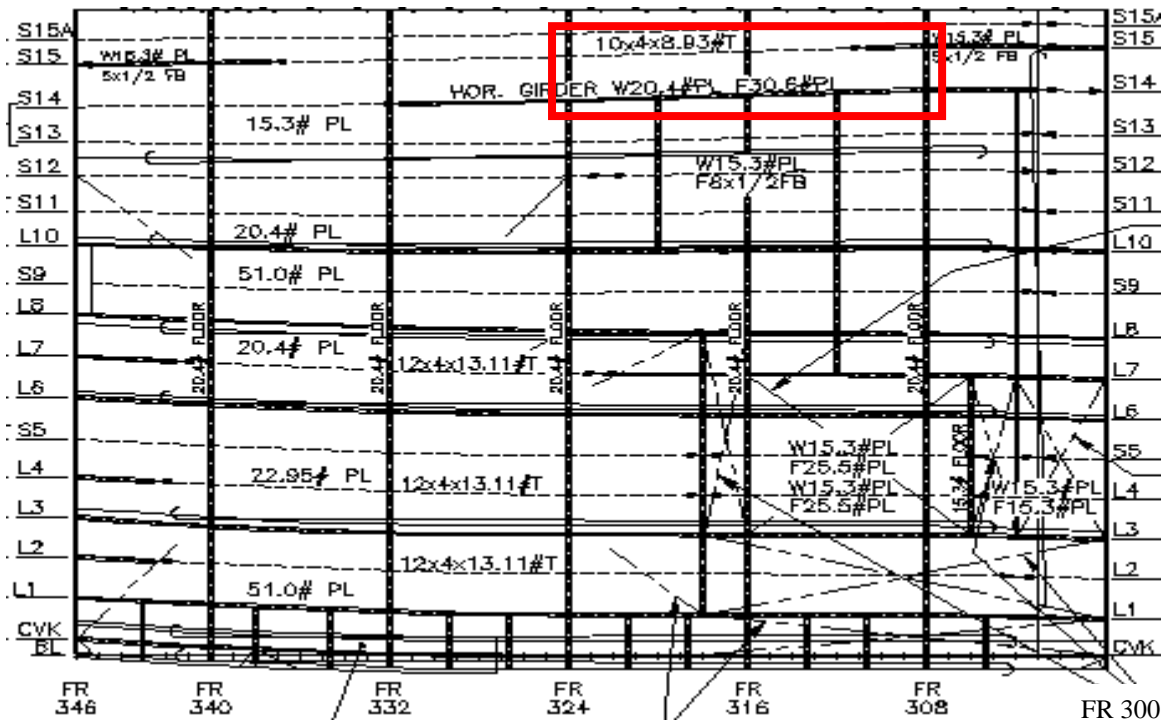
STBD SIDE, MAIN ENGINE ROOM NO.2 (5-300-0-E)
BETWEEN WF (308-324) STRINGER (14)

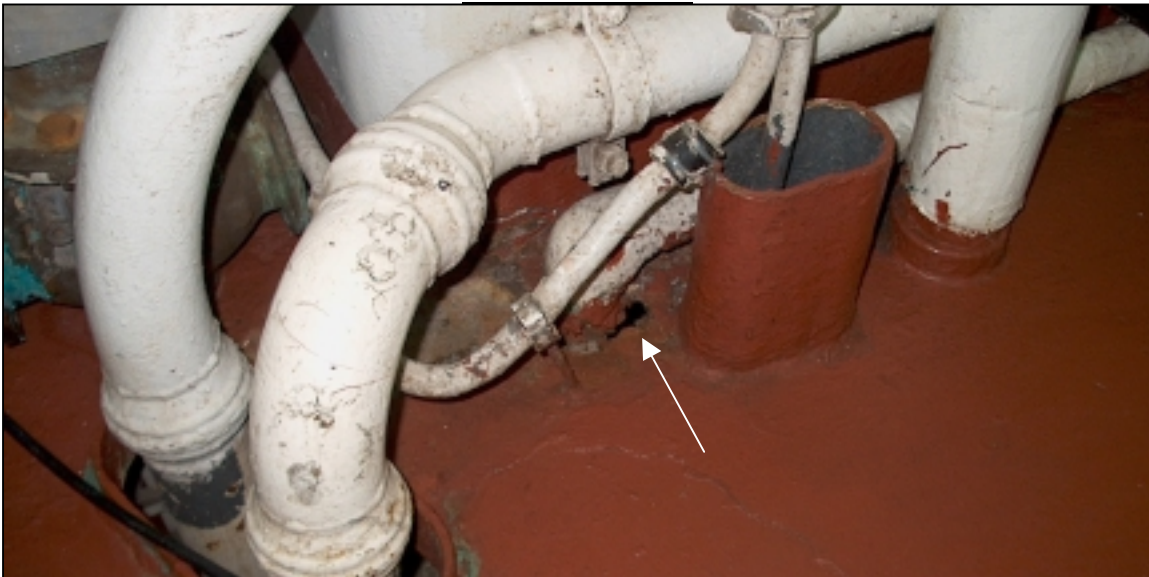
UPPER LEVEL PORT SIDE OF LUBE OIL STORAGE TANK (2-316-6-F)
ARROW INDICATES HOLE IN DECK. JSN # 5787

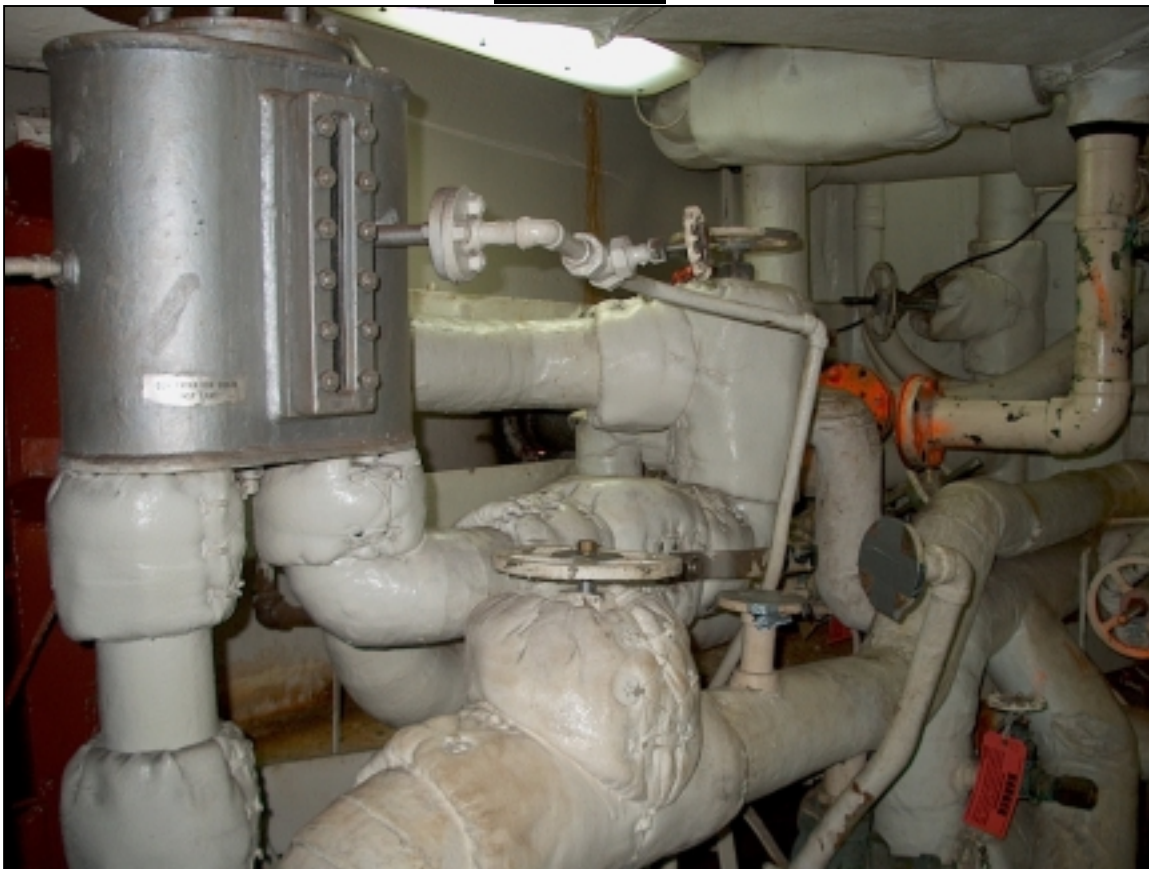
"CONDENSATE CORNER" PORT SIDE, LOWER LEVEL, AT BHD (300).

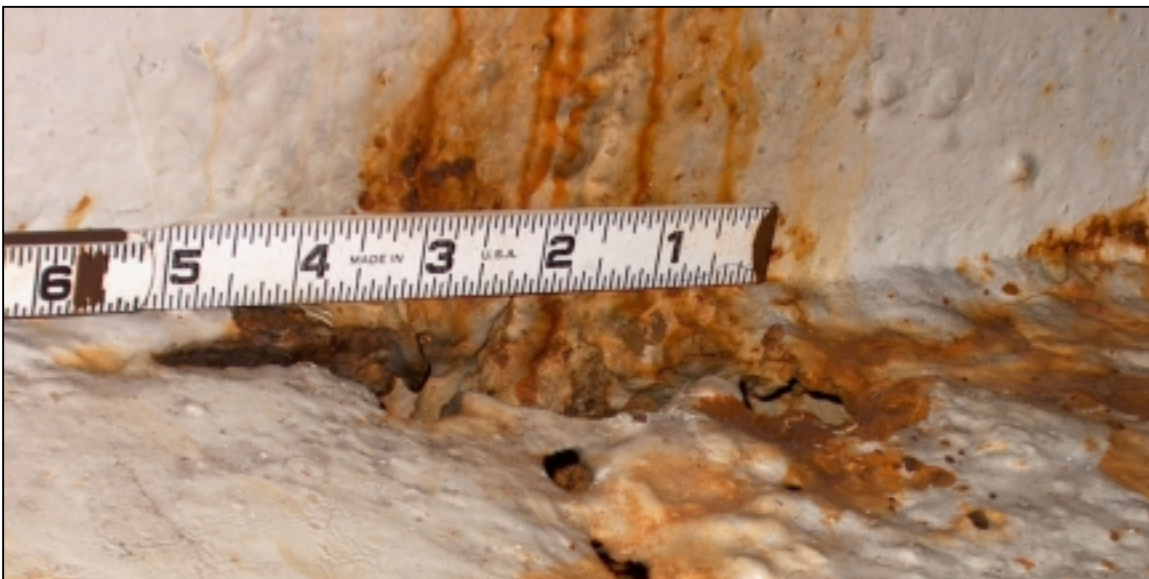
STRINGER (18). DETERIORATED WEB, APPROXIMATELY 3' AFT OF BHD (300).
JSN # 5780

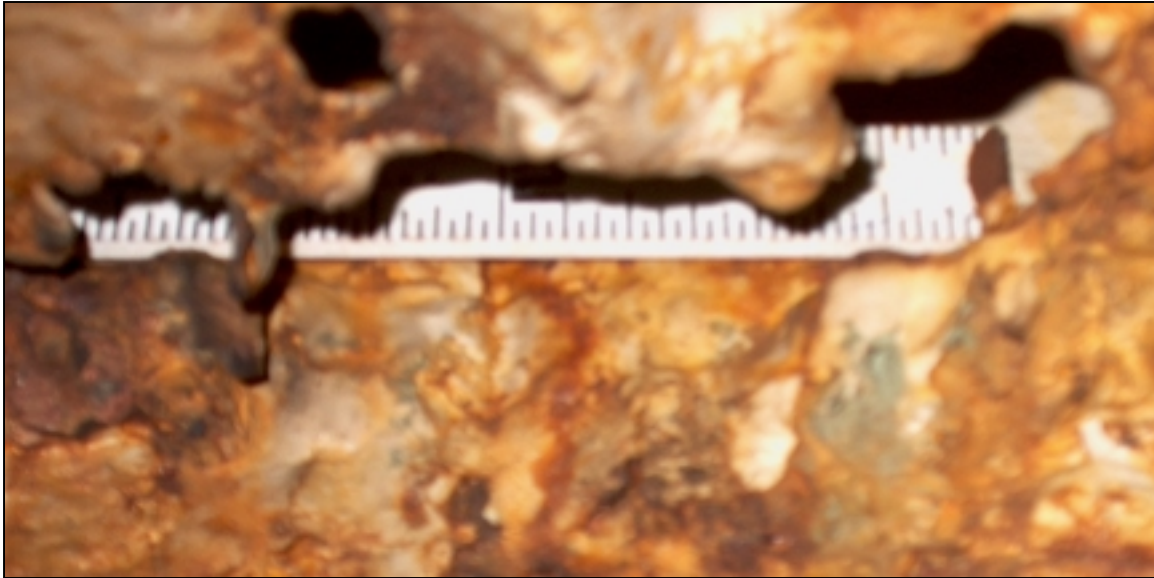
STRINGER (18) FROM BELOW.

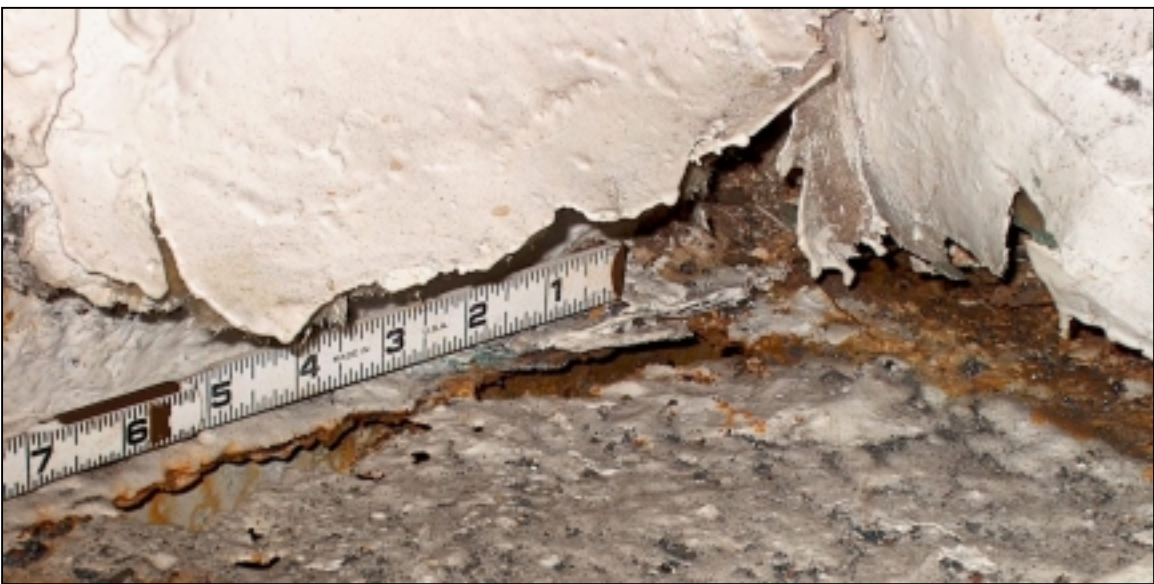
DETERIORATED WEB ON STRINGER (17) AT BHD (300). JSN # 5780

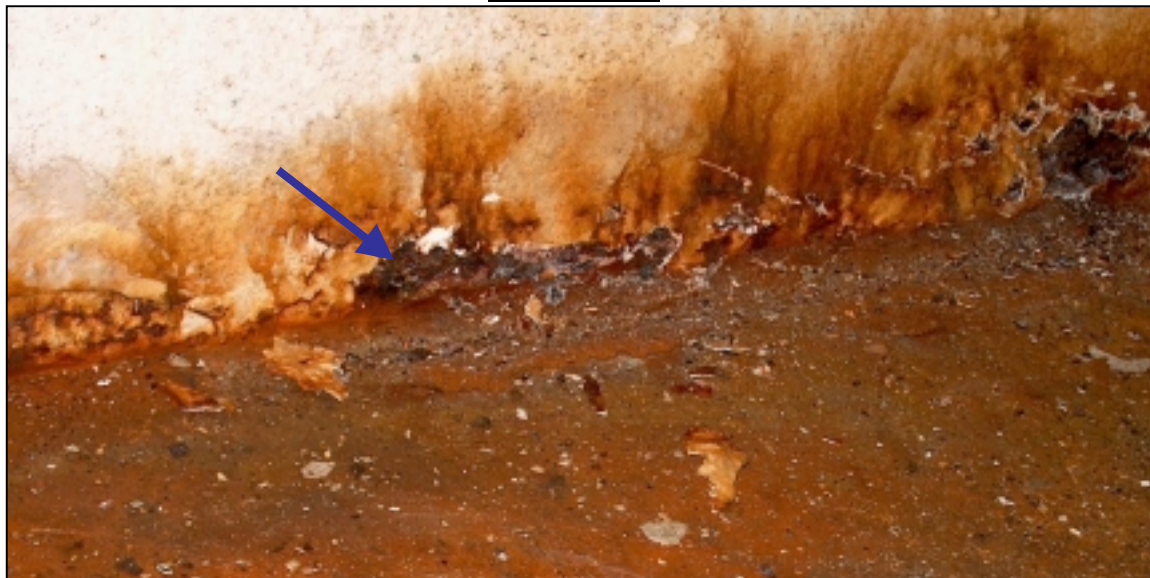
SHELL PLATE AT HORIZONTAL GIRDER (S-16) ARROW INDICATES DEEP
WASHOUT OF WELD.

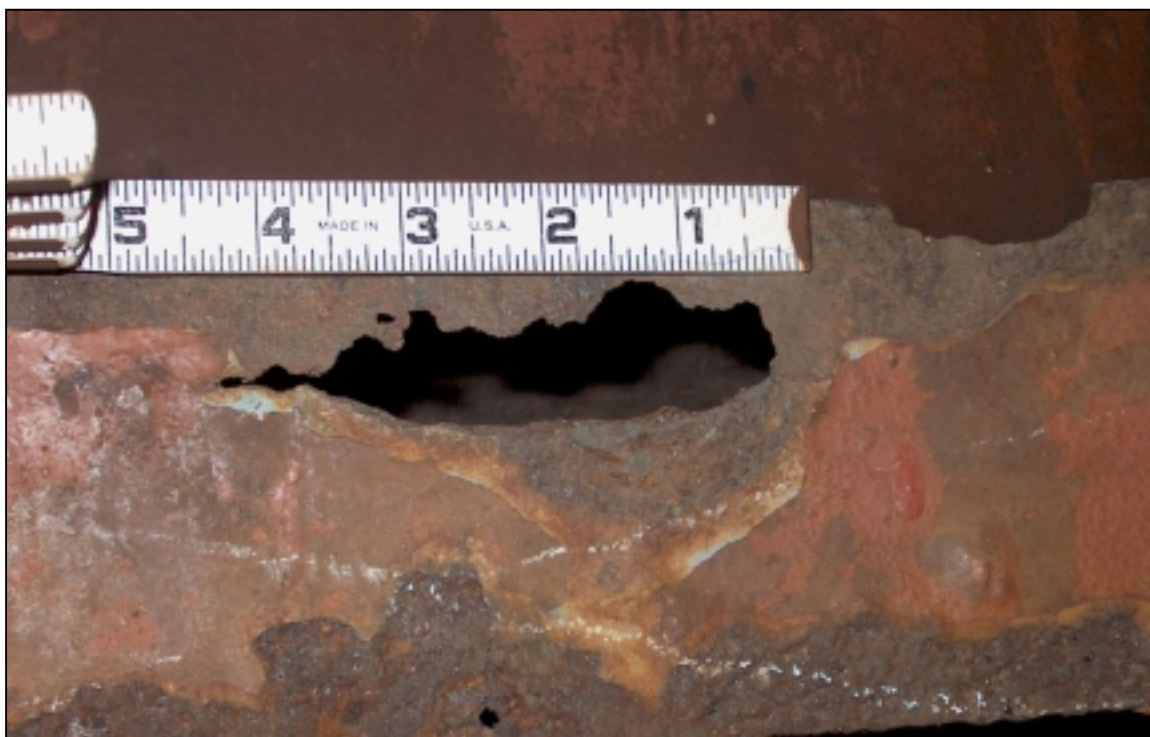
DETERIORATED FLANGE, STRINGER (14) BETWEEN WEB FRAMES (308-316)

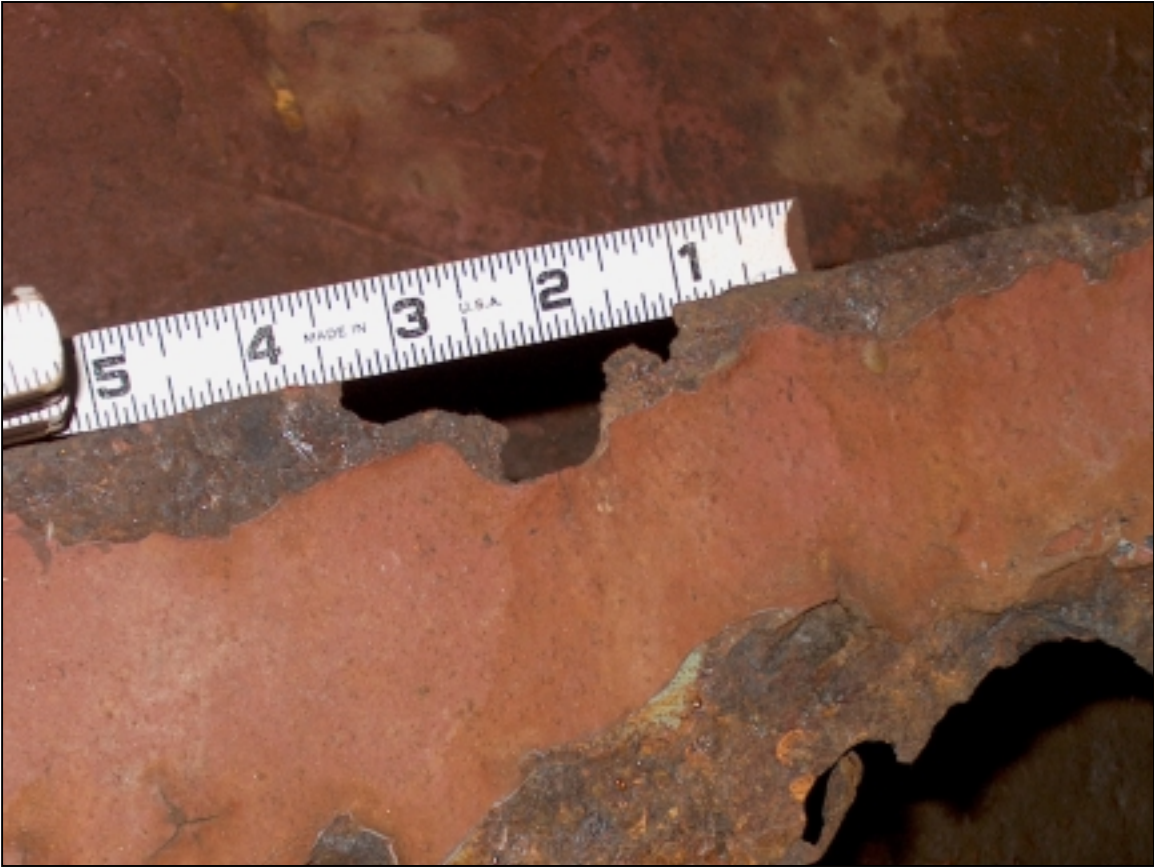
DETERIORATED FLANGE, STRINGER (13) AT WEB FRAME (308)

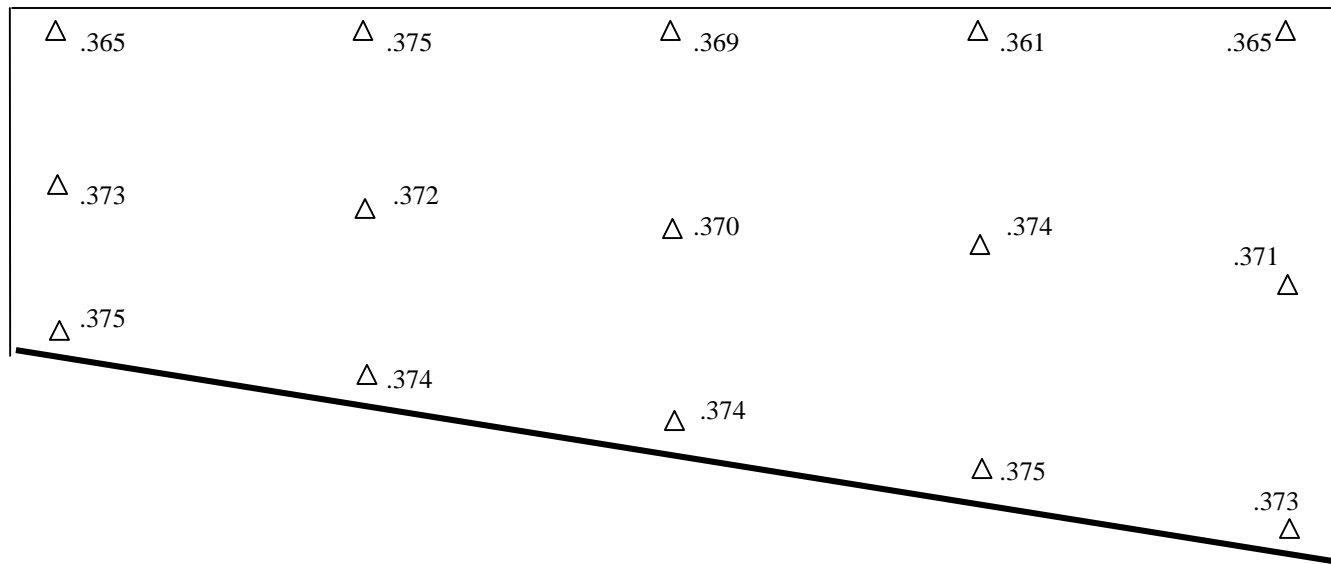
FLANGE DESIGN THICKNESS .500 MINIMUM .375

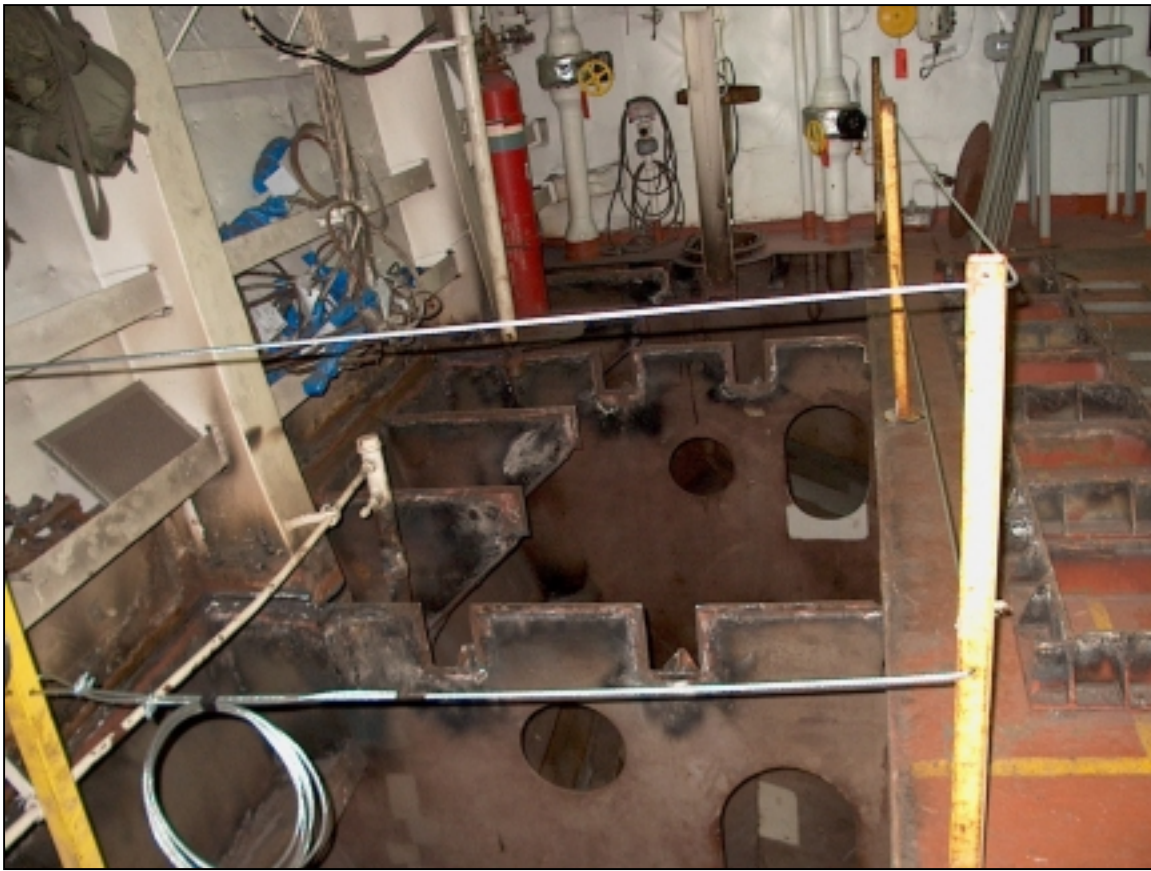
STARBOARD SIDE, UPPER LEVEL REPAIRS TO TANK TOP / DECK FO TANK (6-220-3-F)

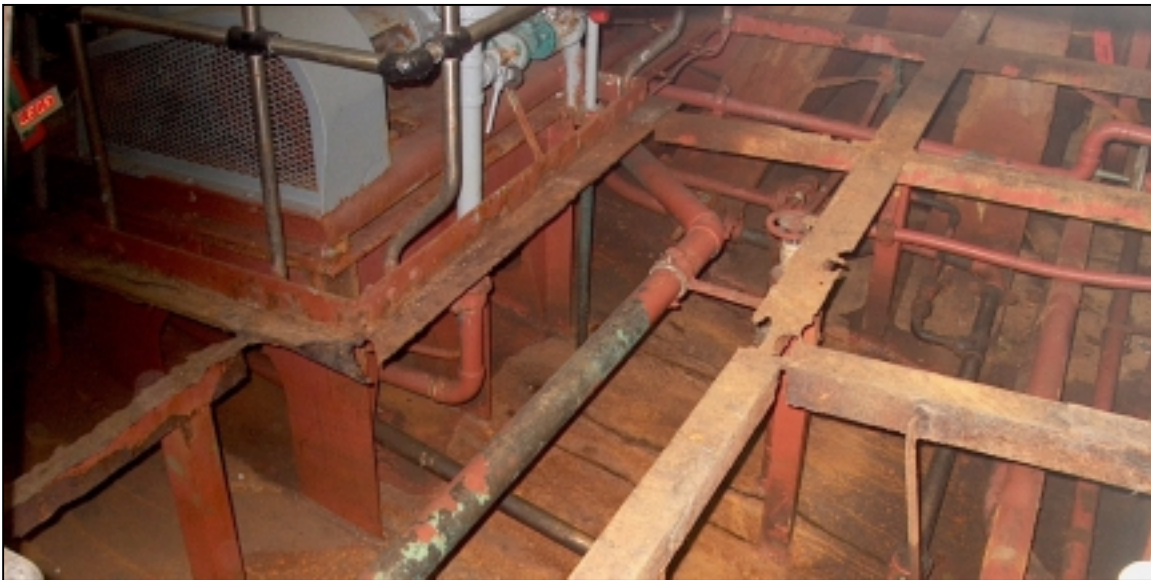
PORT SIDE LOWER LEVEL, SHIPS FORCE HAS REMOVED DECK GRATING FOR REPAIRS
AND PAINTING.

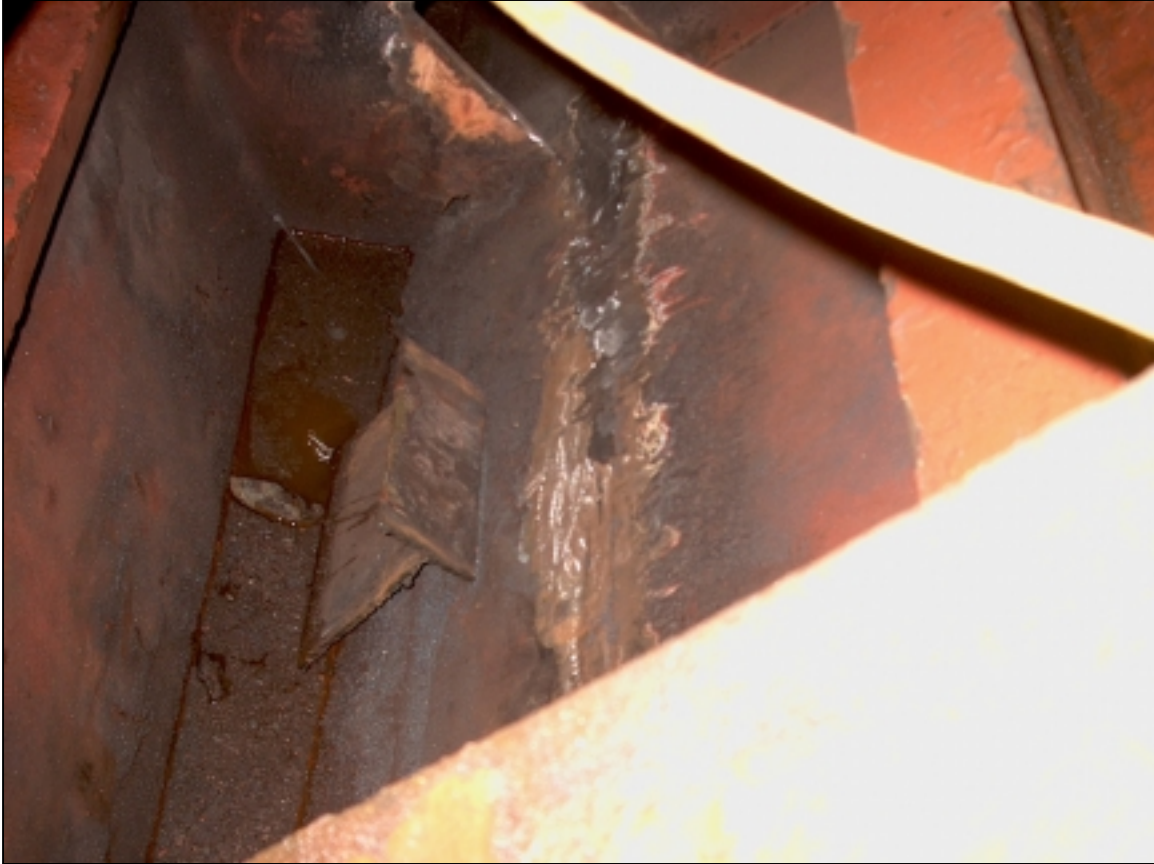
PORT SIDE, STRINGER REPAIR IN PROGRESS. JSN #4694

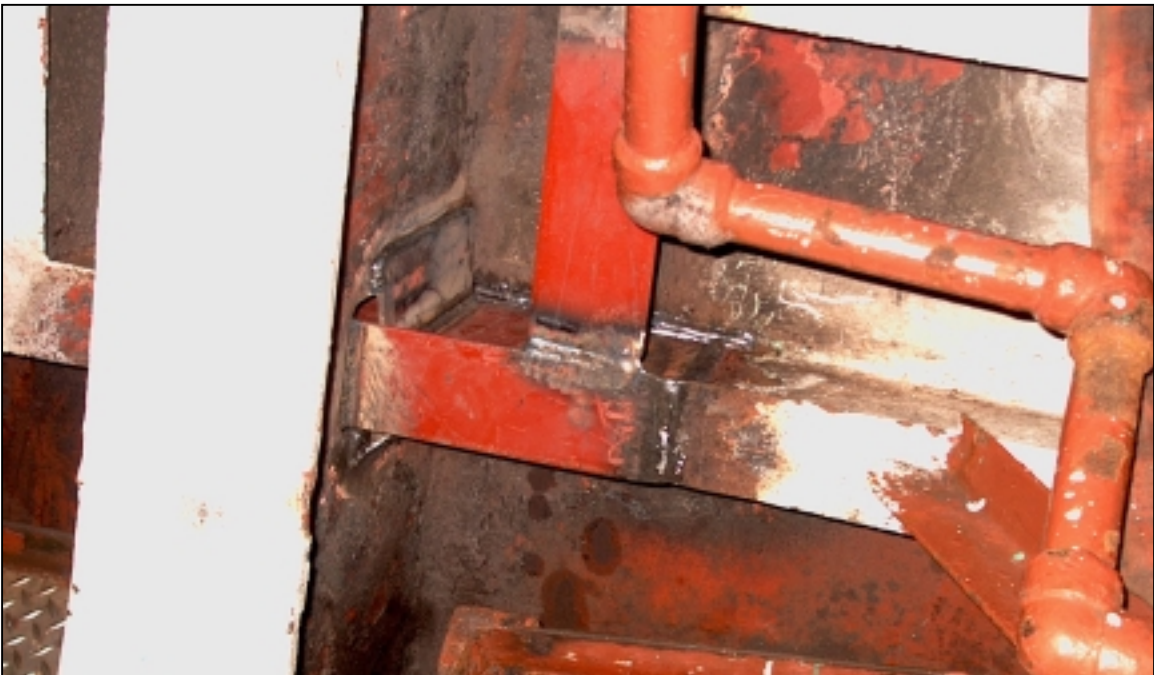
STARBOARD SIDE, STRINGER REPAIR JSN # 4842

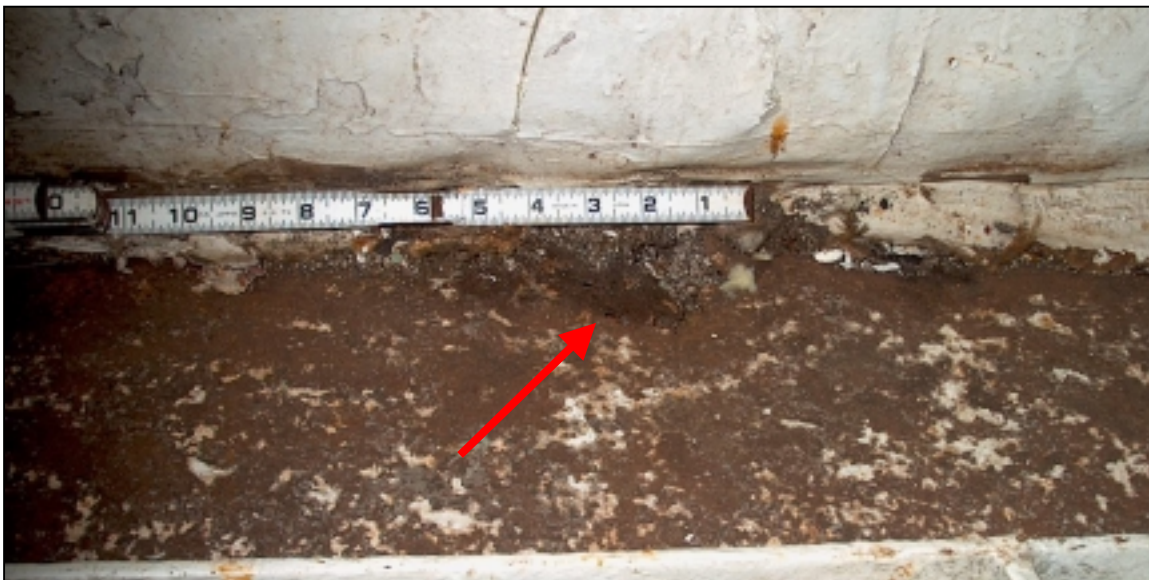
SSPORT C221 POC: J. BRUCKNER (757) 396-4001 EXT 2130, TPOC: J. LaROCK (757) 490-5047							
CSMP SUMMARY: STRINGER (6) STARBOARD SIDE IS DETERIORATED.						TEST# MRC 1102/1	
ROOT CAUSE/AMPLIFICATION: H1						STEP# 1,2,3,4 & 5	
SYSTEM LEVEL IMPACT:							
PART NO.	NOMENCLATURE			QTY	NSN		COST
1							
2							
3							
4							
5							
6							
FIRST CONTACT MEIRS		RATE DC1	SECOND CONTACT BEHERNS		RATE DC3	PHONE	
ASSESSOR / ACT / TECH ID# J. LaROCK/ T. ILGENFRITZ				TD	TL	LOGISTICIAN	TSP

STARBOARD SIDE, WEB OF STRINGER (6) IS SEVERELY DETERIORATED, APPROXIMATELY 46" AFT OF BULKHEAD (138), SEE DRAWING FOR U/T READINGS OF SURROUNDING AREA.

SAFETY HAZARD: 1. SERIOUS - CORRECT AS SOON AS POSSIBLE 2. SERIOUS - SUSPENSION OF EQUIPMENT/SYSTEM/SPACE REQUIRED 3. SERIOUS - WAVIER OF EQUIPMENT/SYSTEM 4. SAFETY ITEM - MINOR 5. COMBUSTIBLE MATERIAL			1. MAINTENANCE ACTION COMPLETED: PARTS DRAWN FROM SUPPLY 2. MAINTENANCE ACTION COMPLETED: REQUIRED PARTS NOT DRAWN FROM SUPPLY 3. MAINTENANCE ACTION COMPLETED: NO PARTS REQUIRED 4. CANCELLED - DEFERRAL WILL BE REMOVED FROM CSMP 5. MAINTENANCE ACTION COMPLETED: 3-M CAPABILITY UTILIZED 6. NONE OF THE ABOVE, DESCRIBE IN REMARKS/DESCRIPTION SECTION			1. MANDATORY 2. ESSENTIAL 3. HIGHLY DESIRABLE 4. DESIRABLE	
DISCREPANCY DESCRIPTION: PER SEMAT I UNDERWATER HULL ASSESSMENT: STBD SIDE (5-138-0-Q) FWD PUMP ROOM NO. 1							
WEB OF STRINGER (6) IS SEVERELY DETERIORATED APPROXIMATELY 46" AFT OF BHD (138). SEE DRAWING FOR U/T READINGS OF SURROUNDING AREA.							
RECOMMENDED REPAIRS: RECOMMEND REPAIR ACTIVITY, REMOVE APPROXIMATELY 8 SF OF HULL BOARD, CUT OUT APPROXIMATELY 3 LF OF STRINGER WEB, REPLACE WITH .250 STEEL. PRIME AND PAINT AREA DISTURBED BY REMOVAL, REPLACE HULL BOARD.

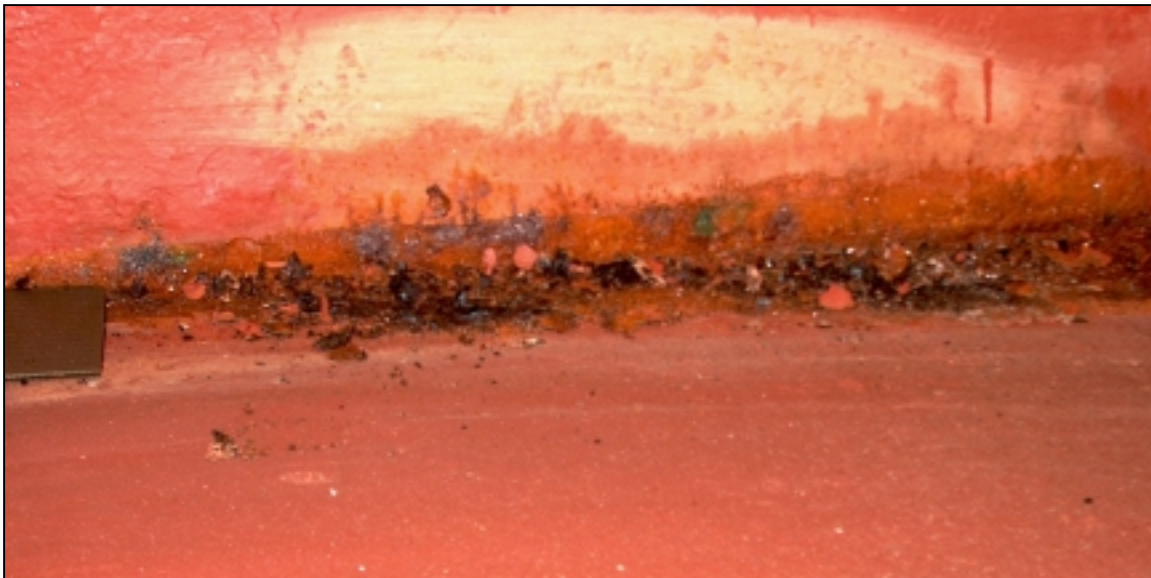
SSPORT C221 POC: J. BRUCKNER (757) 396-4001 EXT 2186, TPOC: J. LaROCK (757) 490-5047								
CSMP SUMMARY:						TEST#		
BILGE POCKET HAS RUST AND PAINT SEPARATION.						MRC 1102/1		
ROOT CAUSE/AMPLIFICATION: H1						STEP#		
SYSTEM LEVEL IMPACT:						1,2,3,4 & 5		
PART NO.	NOMENCLATURE			QTY	NSN		COST	
1								
2								
3								
4								
5								
6								
FIRST CONTACT MEIRS		RATE DC1	SECOND CONTACT BEHERNS		RATE DC3	PHONE		
ASSESSOR / ACT / TECH ID# J. LaROCK/ T. ILGENFRITZ QED SYSTEMS INC.				TD	TL	LOGISTICIAN	TSP

CORROSION IN BILGE POCKET, AFT OF BHD (437), U/T READINGS ARE SATISFACTORY. SEE DRAWING.

SAFETY HAZARD: 1. SERIOUS - CORRECT AS SOON AS POSSIBLE 2. SERIOUS - SUSPENSION OF EQUIPMENT/SYSTEM/SPACE REQUIRED 3. SERIOUS - WAIVER OF EQUIPMENT/SYSTEM 4. SAFETY ITEM - MINOR 5. COMBUSTIBLE MATERIAL		1. MAINTENANCE ACTION COMPLETED: PARTS DRAWN FROM SUPPLY 2. MAINTENANCE ACTION COMPLETED: REQUIRED PARTS NOT DRAWN FROM SUPPLY 3. MAINTENANCE ACTION COMPLETED: NO PARTS REQUIRED 4. CANCELLED - DEFERRAL WILL BE REMOVED FROM CSMP 5. MAINTENANCE ACTION COMPLETED: 3-M CAPABILITY UTILIZED 6. NONE OF THE ABOVE, DESCRIBE IN REMARKS/DESCRIPTION SECTION			1. MANDATORY 2. ESSENTIAL 3. HIGHLY DESIRABLE 4. DESIRABLE			
DISCREPANCY DESCRIPTION: PER SEMAT I UNDERWATER HULL ASSESSMENT: SMALL ARMS MAGAZINE (3-437-2-M) BILGE POCKET								
BILGE POCKET AT BHD (437) AND BETWEEN WEB FRAMES (448-452) HAS RUST, HEAVY PAINT SEPARATION. U/T READINGS ARE SATISFACTORY SEE DRAWING.								
RECOMMENDED REPAIRS								
RECOMMEND SHIP'S FORCE CLEAN AREA TO BARE METAL, PRESERVE AND PAINT. APPROXIMATELY 30 SF.

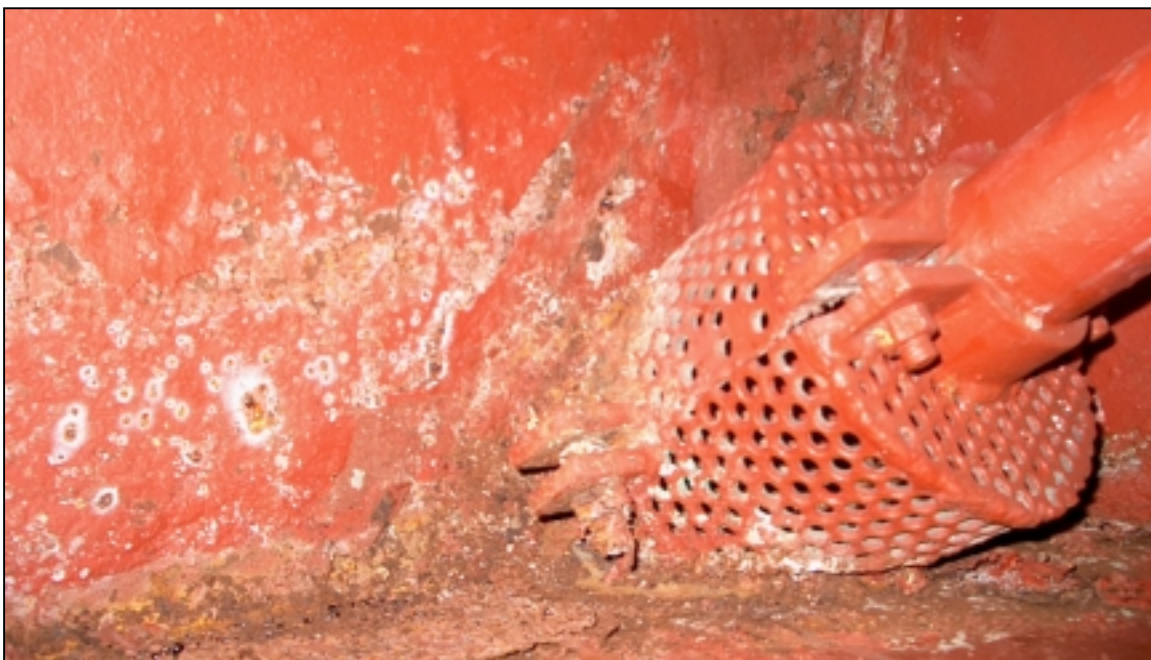
BILGE POCKET AFT OF WEB FRAME (448)

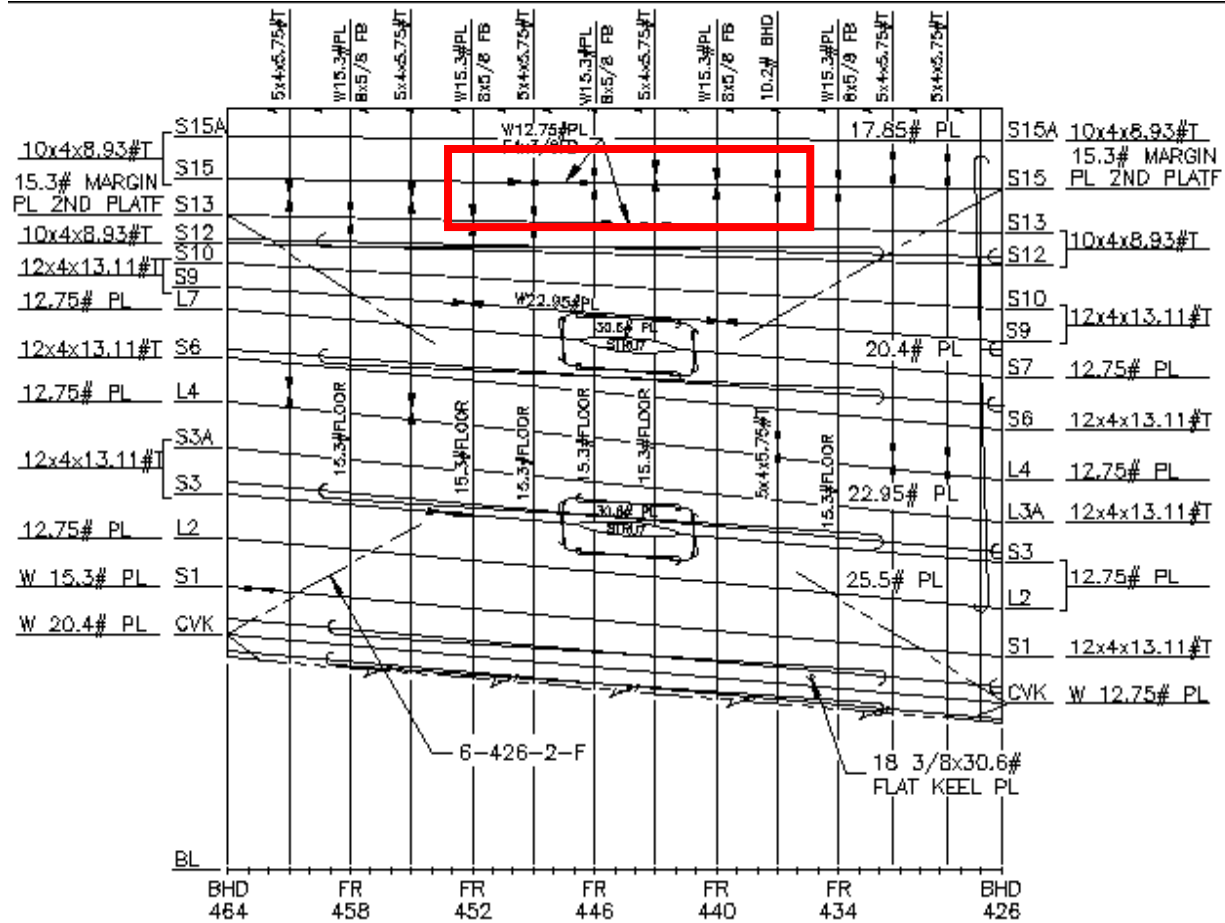
SMALL ARMS MAGAZINE (3-437-2-M)

WEB FRAME 452				WEB FRAME 446		WEB FRAME 440		BHD 437
SHELL DESIGN THICKNESS .438								
MINIMUM .328								
MARGIN PLATE .375								
MINIMUM .287								
Δ .437	.438Δ	Δ .438	.438Δ			Δ .442	.440Δ	.436Δ
Δ .436	.434Δ	Δ .437	.436Δ			Δ .437	.438Δ	.438Δ
Δ .370	.372Δ	Δ .373	.361Δ			Δ .361	.371Δ	.369Δ
Δ .375	.376Δ	Δ .375	.372Δ			Δ .375	.375Δ	.377Δ

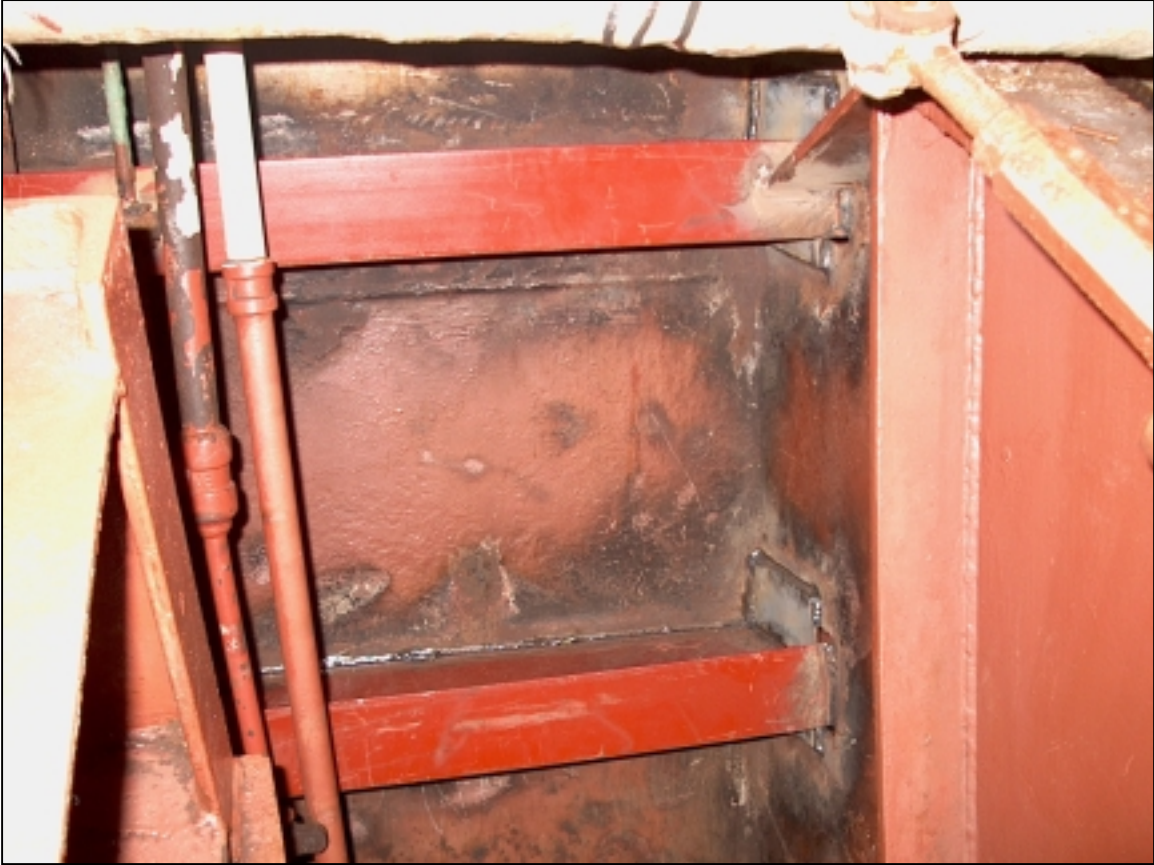
STRINGER REPAIRS JSN # 5545
